Laboratory testing and on-site experiments to characterize Corona discharges in VHF-band

Abstract

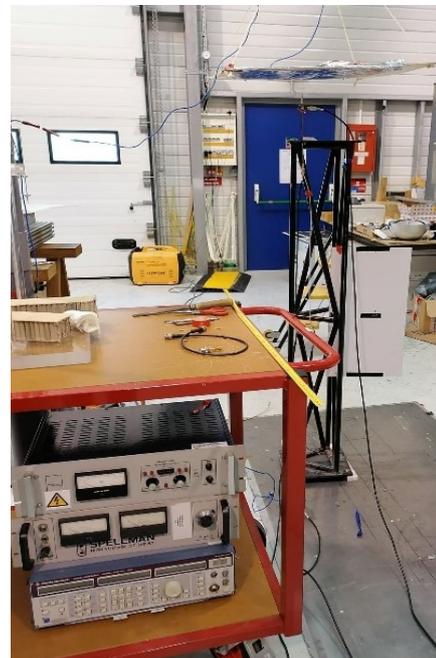
Fig. 1: Model pylon

For the laboratory experiment, we have a model pylon of 143 cm high structure made of steel with a triangular base with a lightning rod of 10 cm length at the top, the whole structure is grounded. A metal plate with negative high voltage is placed 7 cm above the pylon. We use a bipolar high-voltage power supply up to 70 kV. The pylon is shown in Fig. 1.

Current measurements are performed at the lightning rod with a shunt at the top and a probe at the base, to compare these different techniques. For the base of the pylon, there is one current probe to measure all the currents on the metallic structure. The current probes are Pearson transformers of 1 V/A and 2 V/A ratio. They are placed in order to measure a negative current when negative discharges occur.

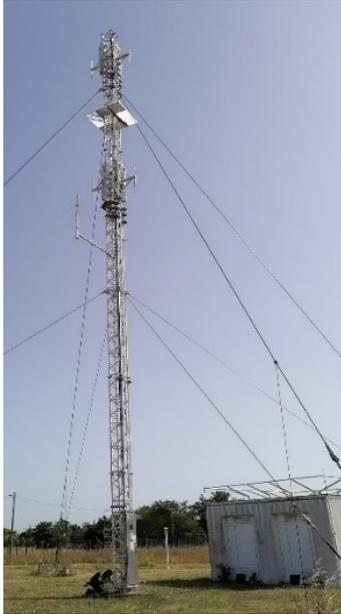
Fig. 2: Test pylon

The test pylon is a square based pylon of dimensions 25 m x 0.5 m x 0.5 m made of steel and shown in Fig. 2. It has a 1 m lightning rod at the top and is grounded. We use two currents probes to measure the current at the base of the pylon, around the ground cable, and at the base of the lightning rod. The acquisition system is placed in a local next to the pylon and works autonomously. The trigger is set to 20 mA and we receive the data via emails as shown in Fig. 3.
